**Limb Deformity Case Study #2:** Patient is a 14 year old female who initially presented with a right knee flexion deformity, a 20° arc of knee motion (60°-80° of flexion), and growth arrest of her right distal femoral growth plate. Her injuries were the result of a skiing accident that she sustained 10 months prior to presentation at HSS. As a result of her accident she sustained a right tibial spine avulsion fracture that was initially treated (at an outside institution) with surgical repair of the avulsed tibial spine. She went on to develop a knee flexion contracture and, according to the report, was brought back to the operating room for a knee manipulation approximately three months after the arthroscopic tibial spine repair. Approximately two weeks post manipulation she was diagnosed with a distal femur physeal fracture and was treated with casting for six weeks.

Surgical plan: Two-stage procedure. Stage 1 - Correction of the right distal femur deformity utilizing an osteotomy and blade plate fixation. Stage 2 – Arthroscopic lysis of the soft tissue adhesions and screw epiphysiodesis of the left knee.

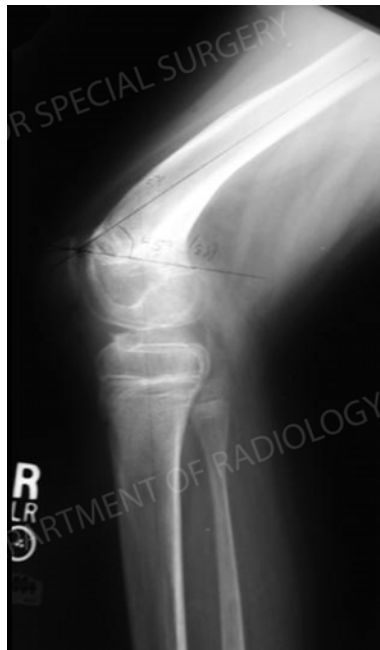
Figure 1: Lateral x-ray image of the right knee obtained during her initial presentation to HSS.

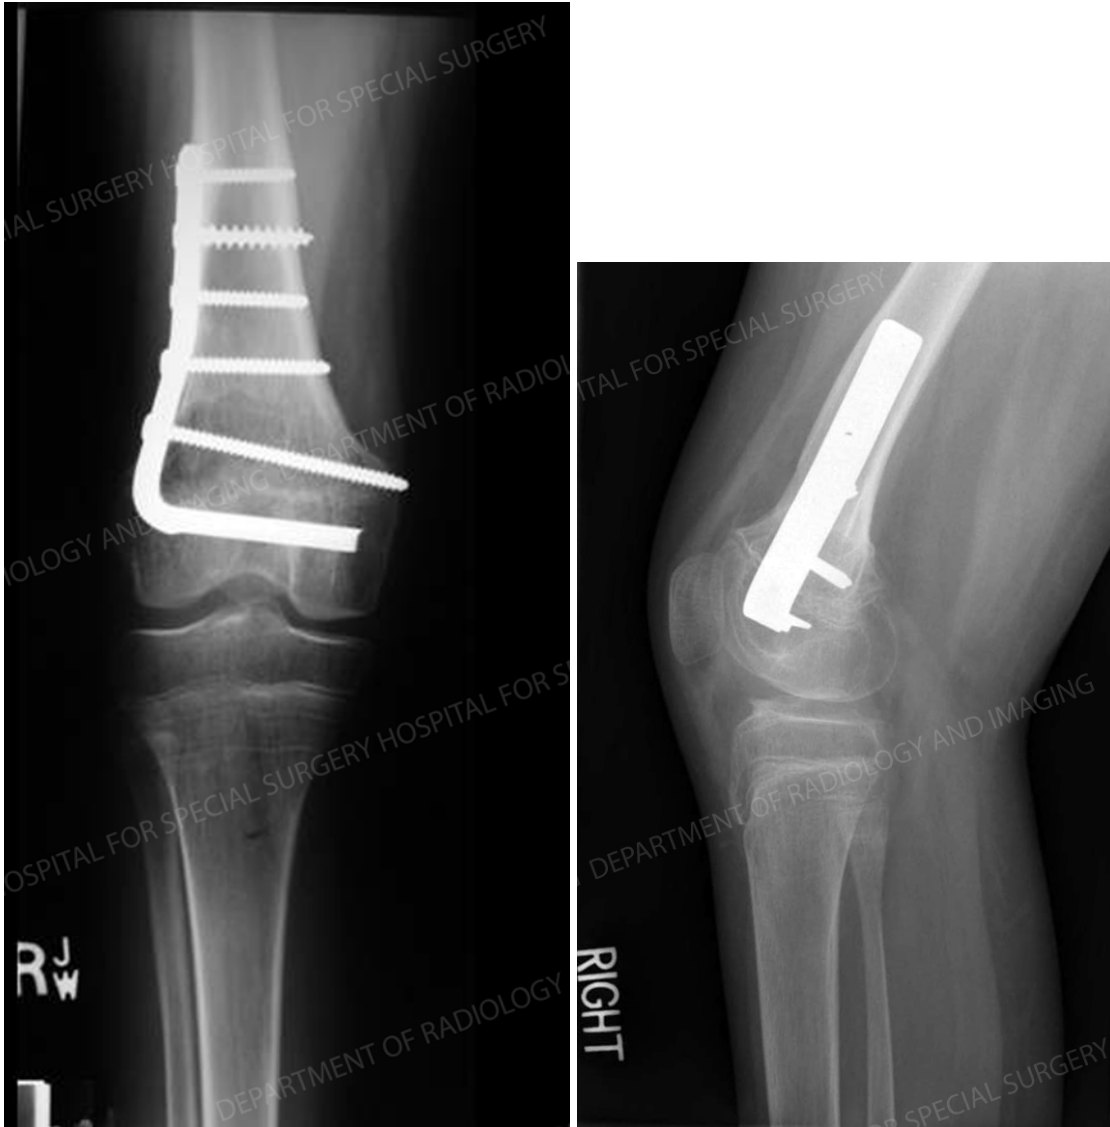
Figure 2A and 2B: Post-operative AP and lateral x-ray images of the right knee after surgical correction of the distal femoral knee flexion deformity and arthroscopic adhesion lysis.

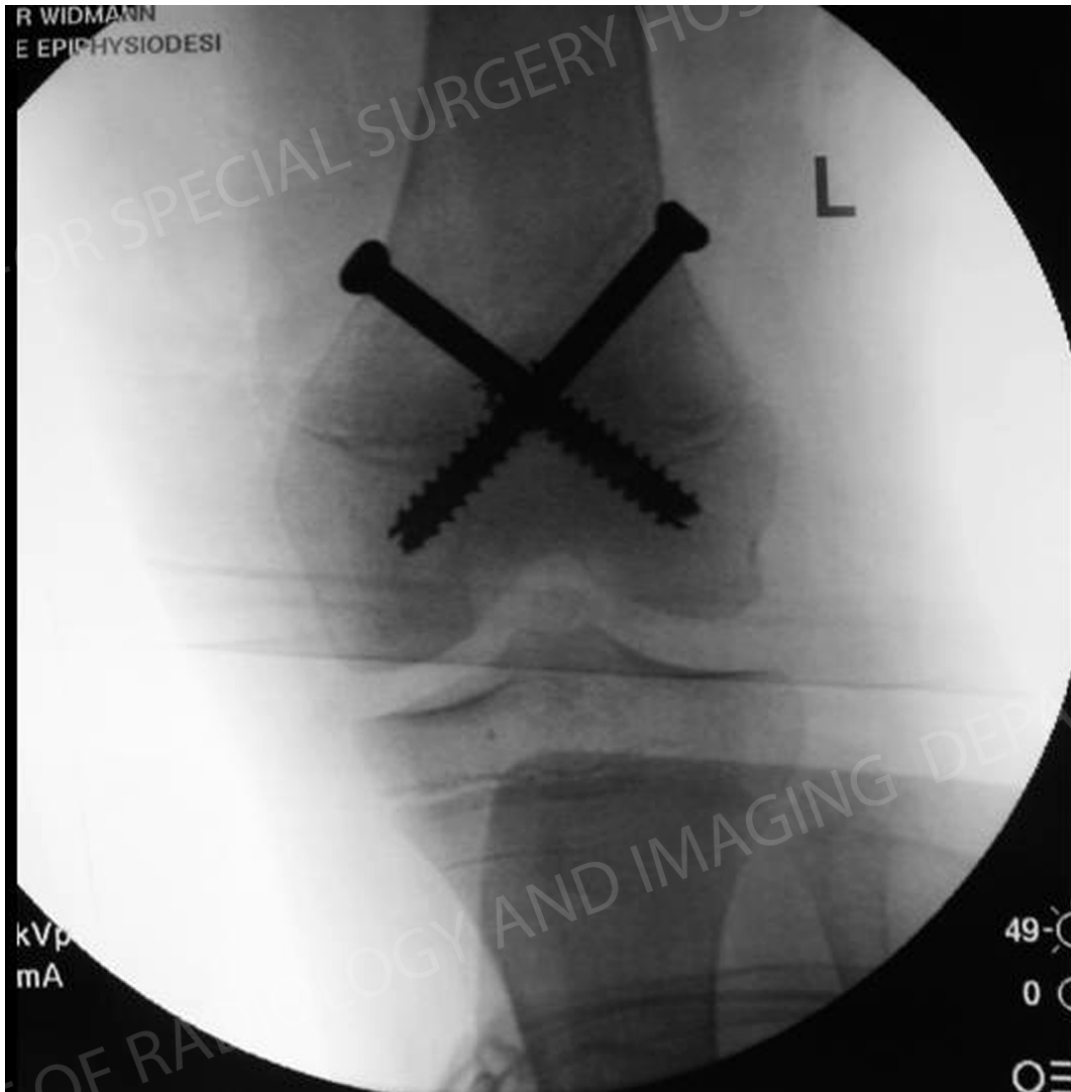
Figure 3: Post-operative x-ray image demonstrating screw epiphysiodesis of the left knee.

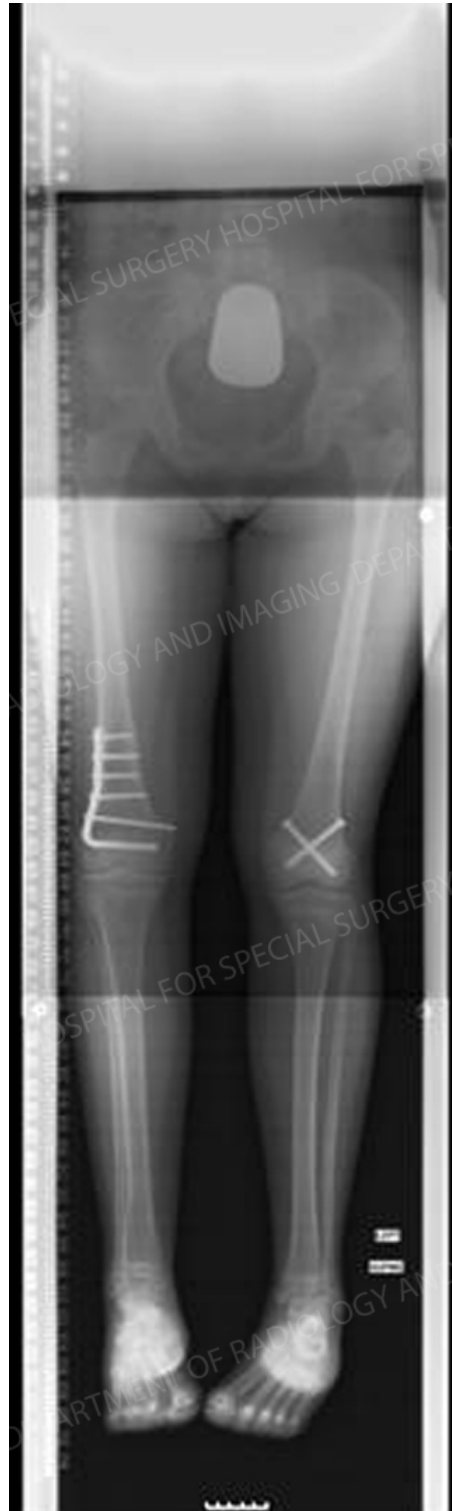
Figure 4: Scanogram x-ray obtained three years postoperatively, demonstrating good alignment and limb symmetry within clinical tolerance.
